**Docket No. 217 – Development and Management Plan Inspection**

Northeast Utilities Service Company Certificate of Environmental Compatibility and Public Need for the construction of a 345-kV electric transmission line and reconstruction of an existing 115-kV electric transmission line between Connecticut Light and Power Company's Plumtree Substation in Bethel, through the towns of Redding, Weston, and Wilton, and to the Norwalk Substation in Norwalk, Connecticut.

**Date:** October 25, 2006

**Location:** 345kV Underground Route

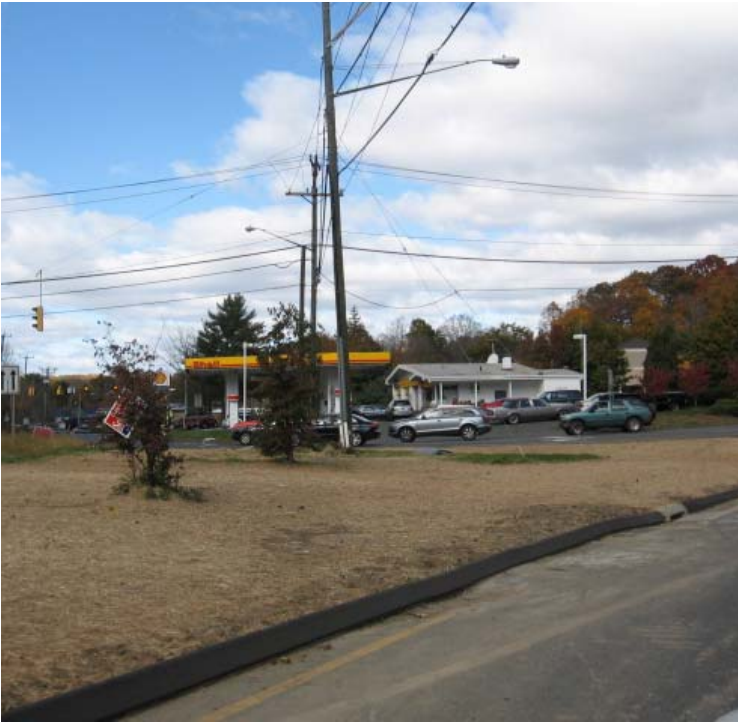
- The entire Rt. 107 & 7 intersection island has now been graded and mulched with hay.
  - Area is temporarily stabilized and vegetative cover is not likely prior to the winter. 10/25/06

Photo on the left shows the Rt 7/107 intersection which has been fully mulched with hay and temporarily stabilized. Vegetative cover is not expected prior to the winter. Photo on the right shows the Four Seasons racquet club where several large stockpiles are stored. Place controls in the swale here and restore to original conditions when the area is demobilized. 10/25/06

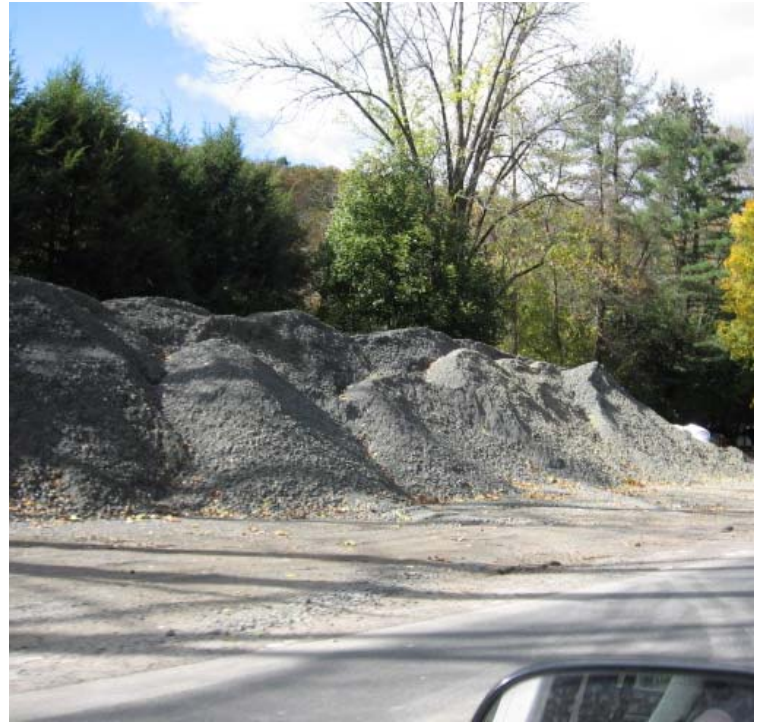
- The 4 Seasons racquet club storage yard has several large stockpiles and the area still has active equipment. This area is still utilized with ruts in the soil surface and an unprotected swale.
  - Install haybales at the culvert within the swale in an attempt to filter run-off. 2/2-10/25/06
  - Restore/ temporarily stabilize area when feasible. 9/13-10/25/06

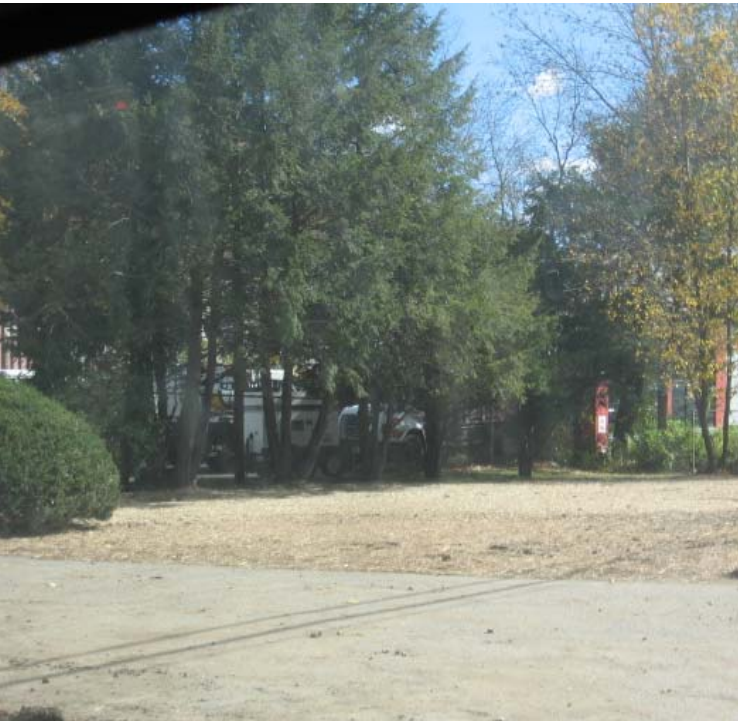
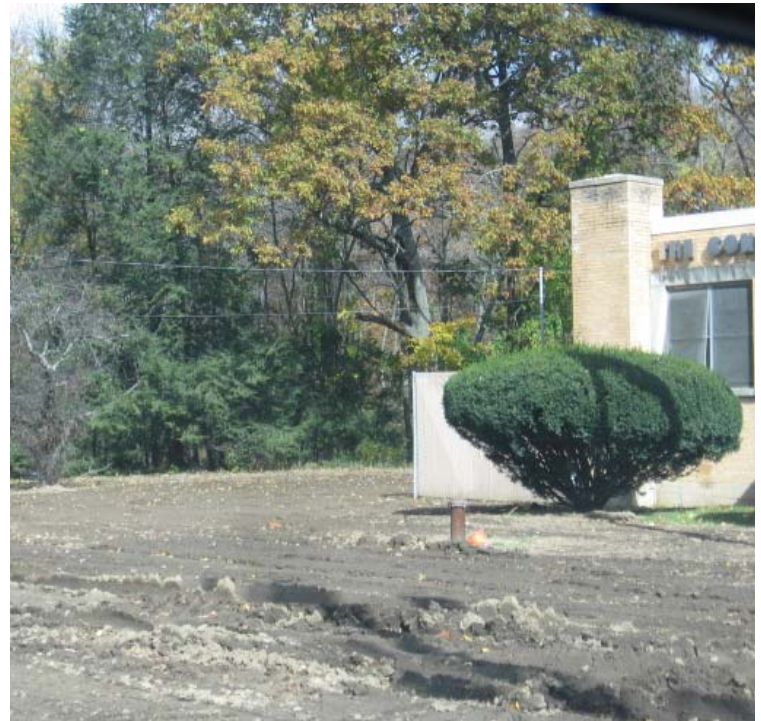
- The contractor trailer yard on Rt 7 at the CL&P office was fully graded and dumpsters were removed. Half of the site had been mulched with hay.
  - Continue to temporarily stabilize the remaining half of the site with mulch or similar. Vegetative cover is not likely prior to the winter. 10/25/06

Both photos show the demobilized contractor trailer yard along Rt 7. The yard is fully graded and dumpsters were removed. Half of the yard has been temporarily stabilized with mulch. Continue to mulch or stabilize the remaining portion of the yard. Vegetative cover is not expected prior to the winter. 10/25/06
